MERRITT &amp; HARRIS, INC.

20-251E

Re: **World Trade Center**  
**New York, New York**

One World Trade Center

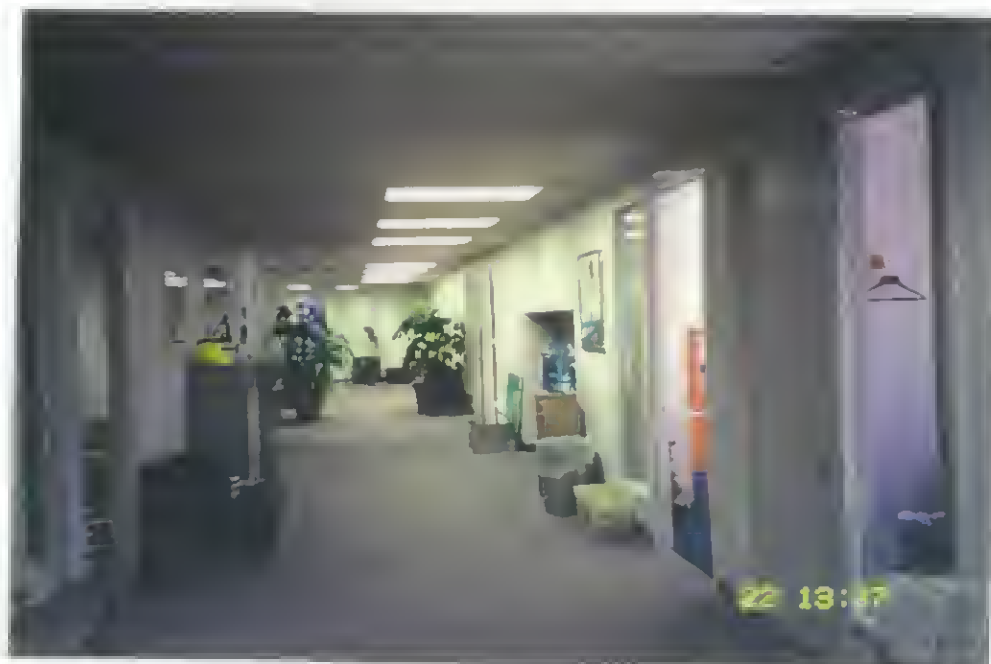
Photograph 21

Typical floor office  
interior

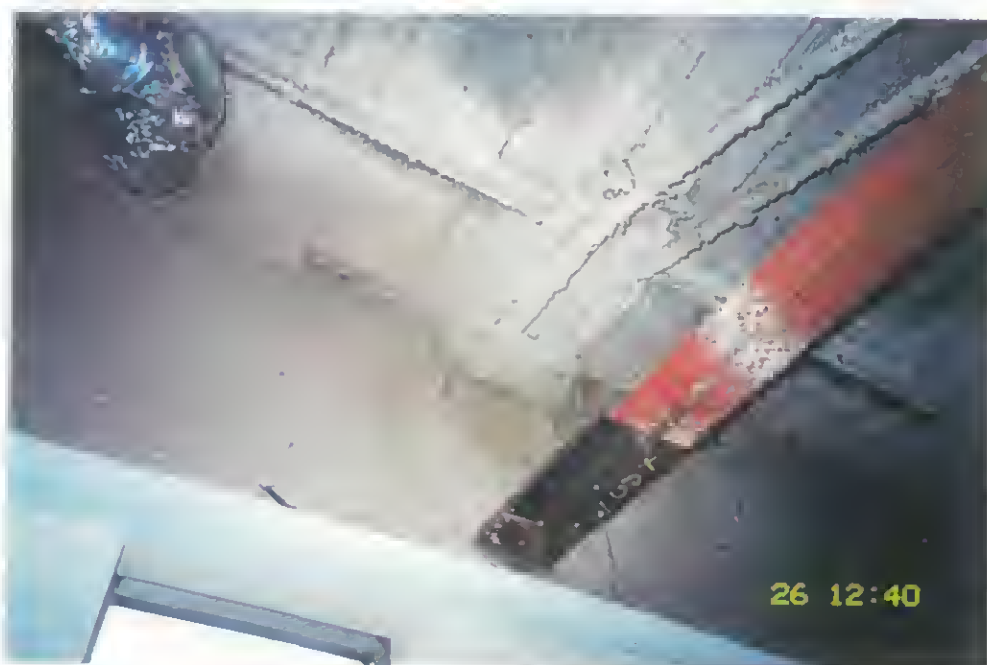
Photograph 22

Viscoelastic damper  
at each floor joist

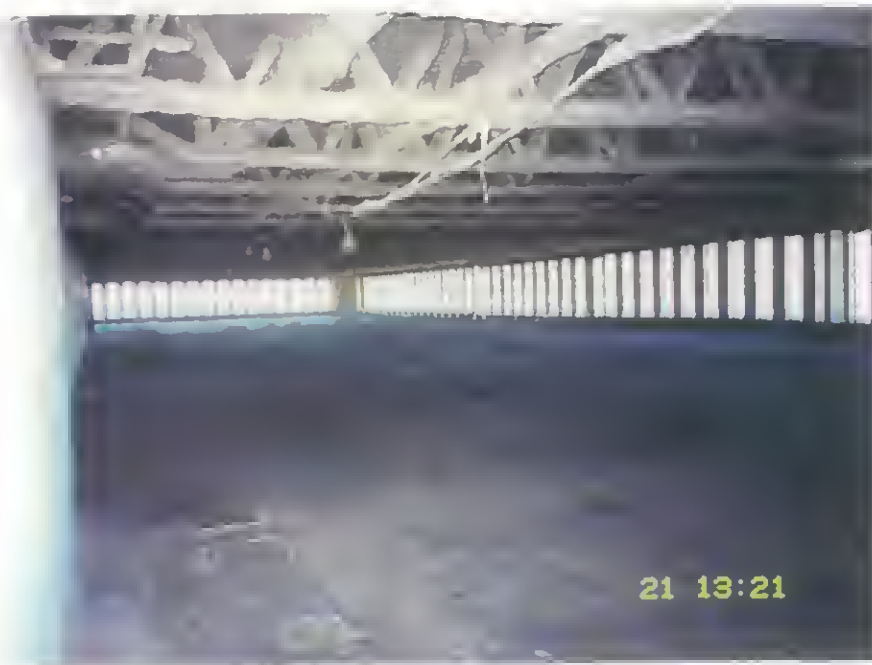
Photograph 23

Typical floor  
framing system after  
fireproofing  
respraying

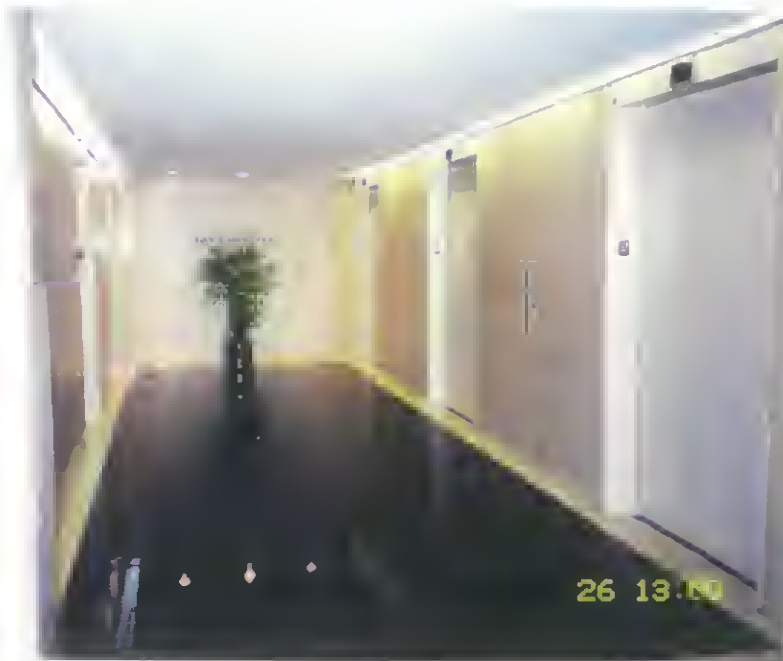
Photograph 24

Upgraded elevator  
lobby, by tenant

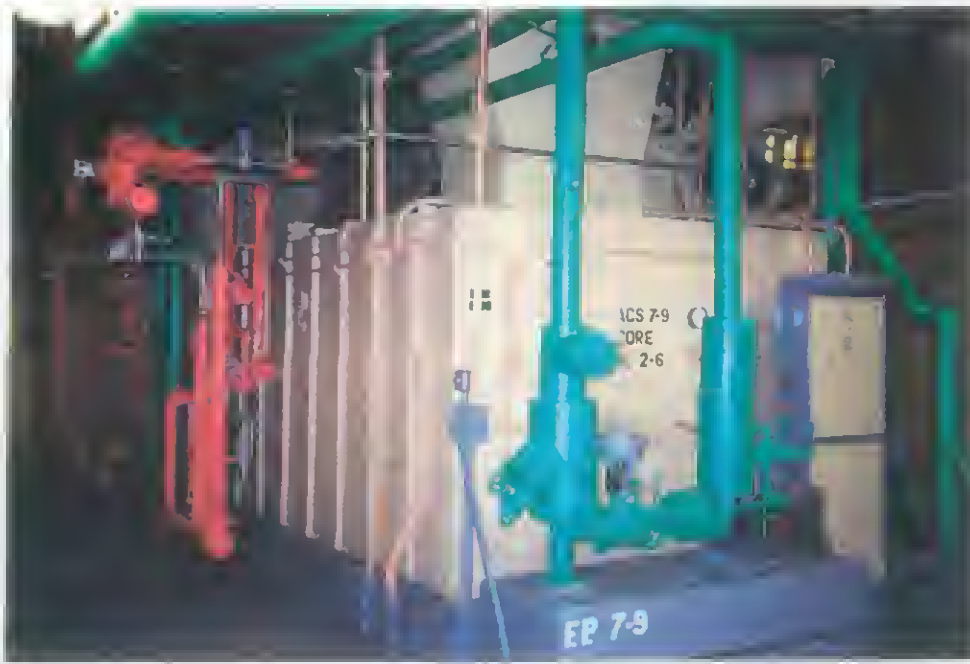
**Photograph M1**

Typical 7th floor  
mechanical room air  
handler and  
abandoned freeze  
protection pump  
system

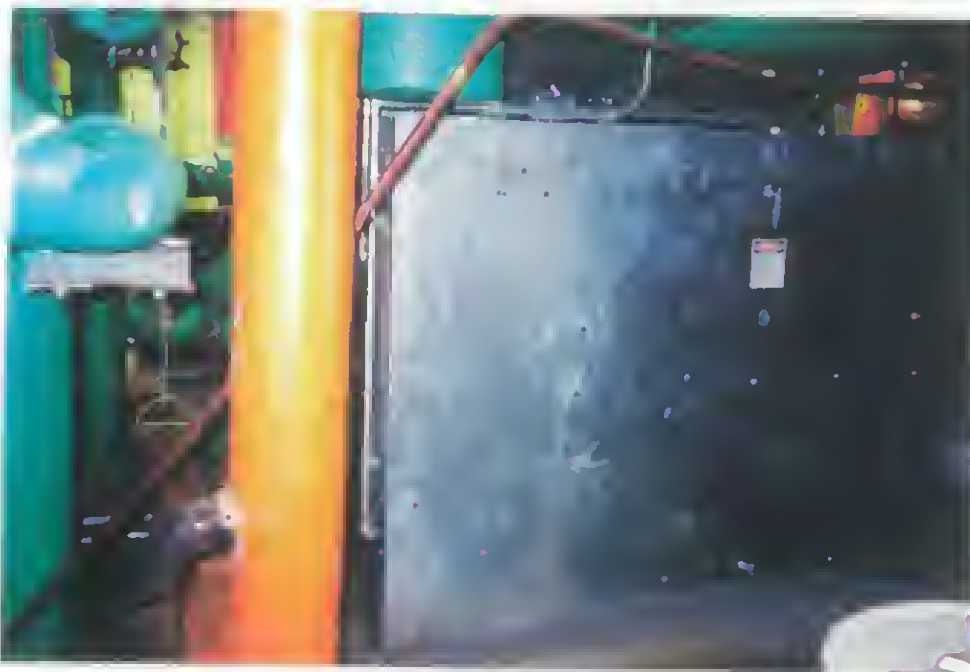
**Photograph M2**

New air handling  
unit for the  
electrical  
substation on the  
74th floor

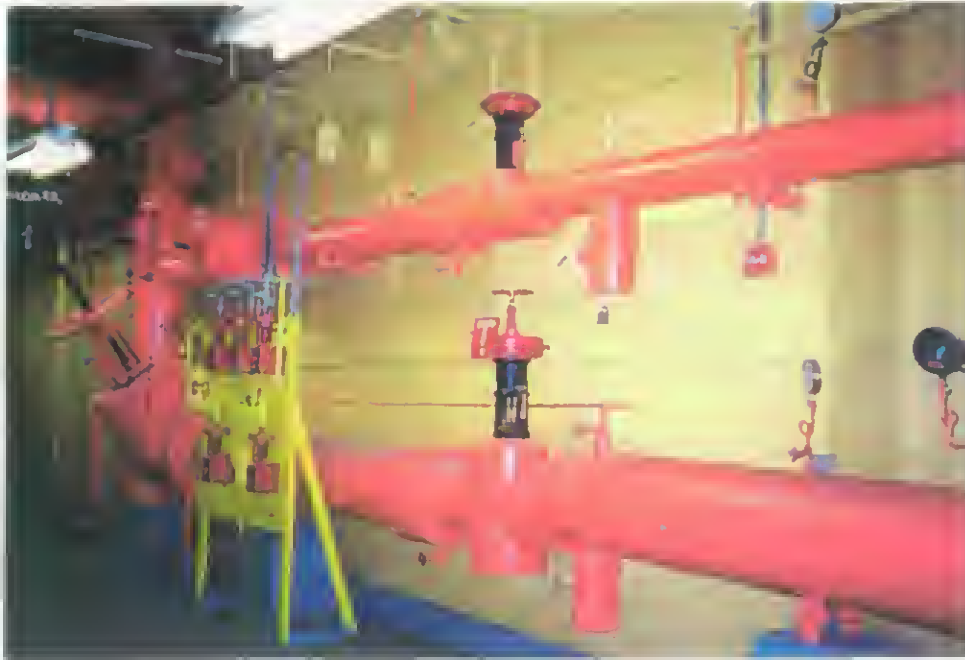
Photograph M3

Steam pressure  
reducing station

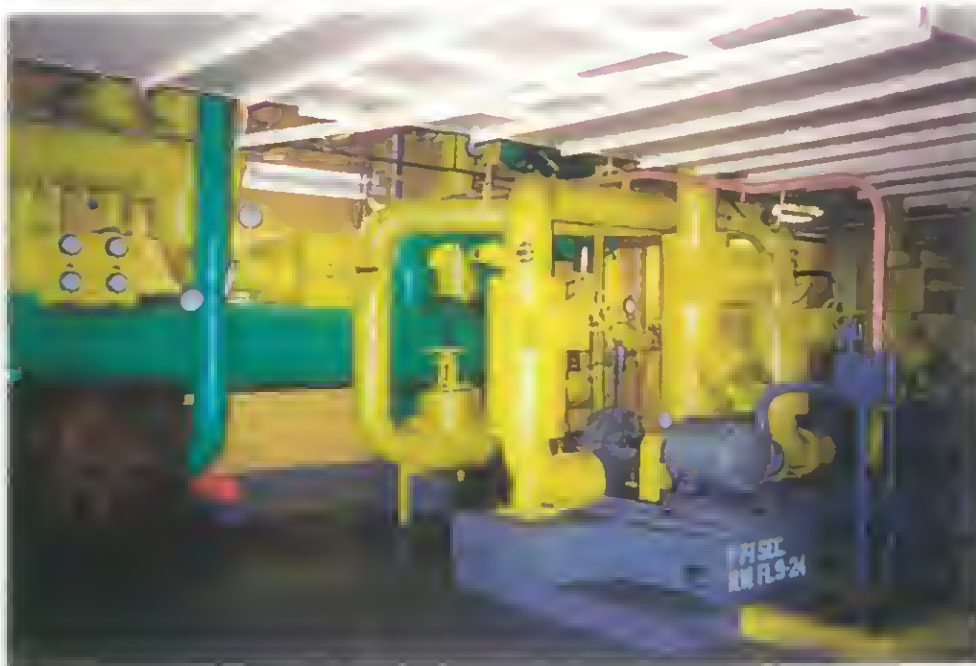
Photograph M4

Steam and  
chilled water  
heat exchangers  
and secondary  
heating/chilled  
water pumps

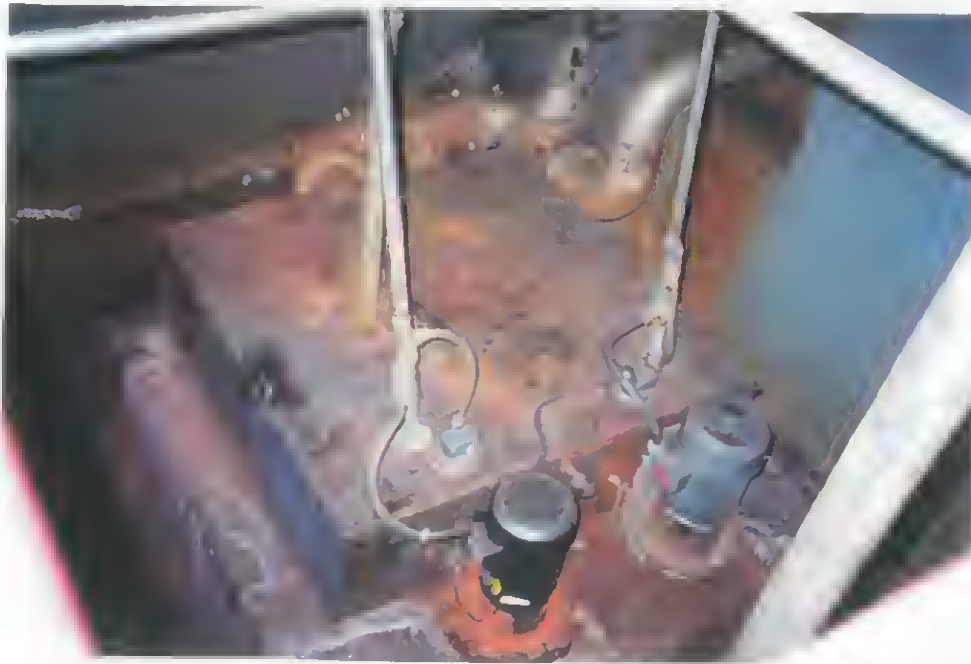
Photograph M5

Steam  
condensate  
return pumps  
and receiver in  
the B-6 Level  
mechanical room

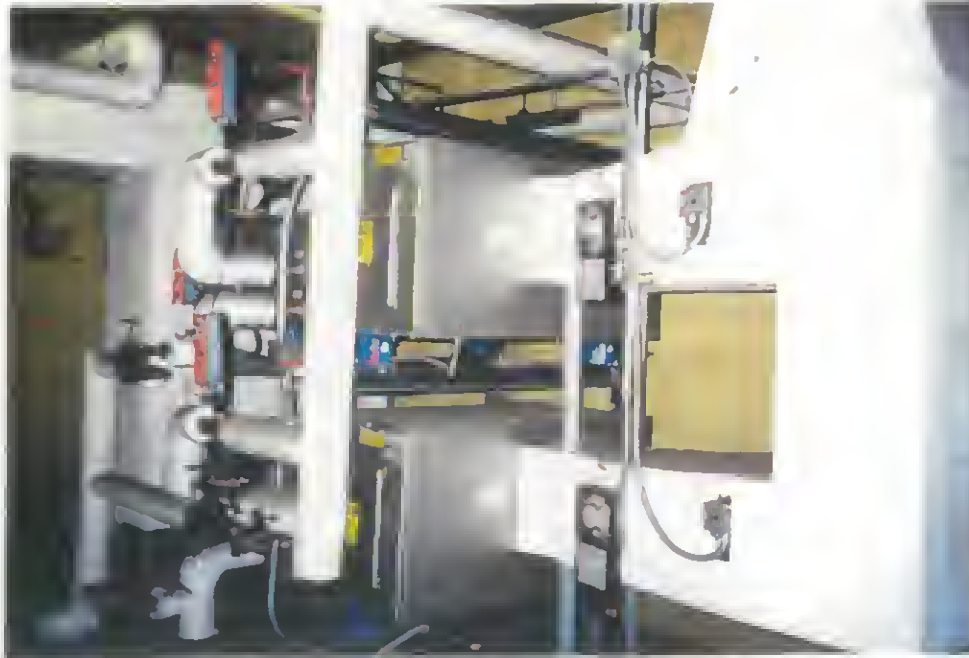
**Photograph M7**

New H&V units,  
with steam coils,  
located in the B-6  
Level mechanical  
room

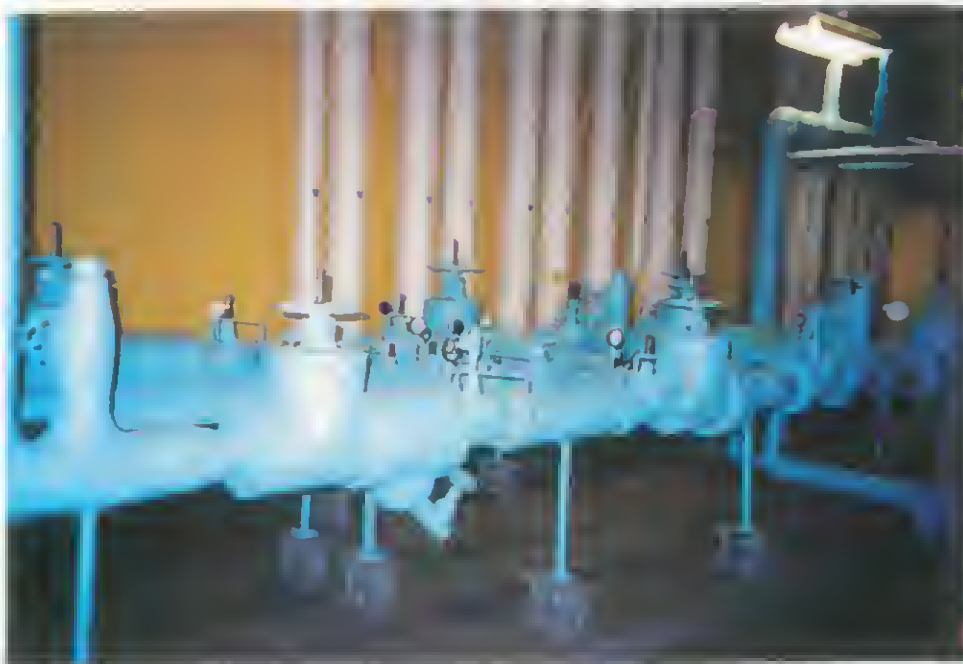
**Photograph M8**

Domestic water  
pressure  
reducing station

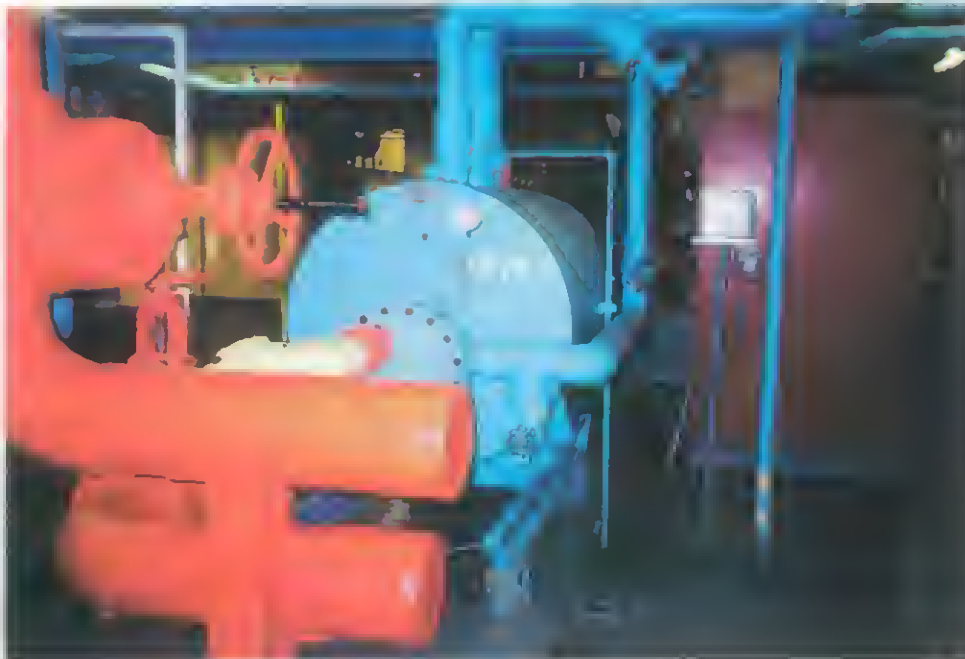
Photograph M10

Domestic water  
preheat tank

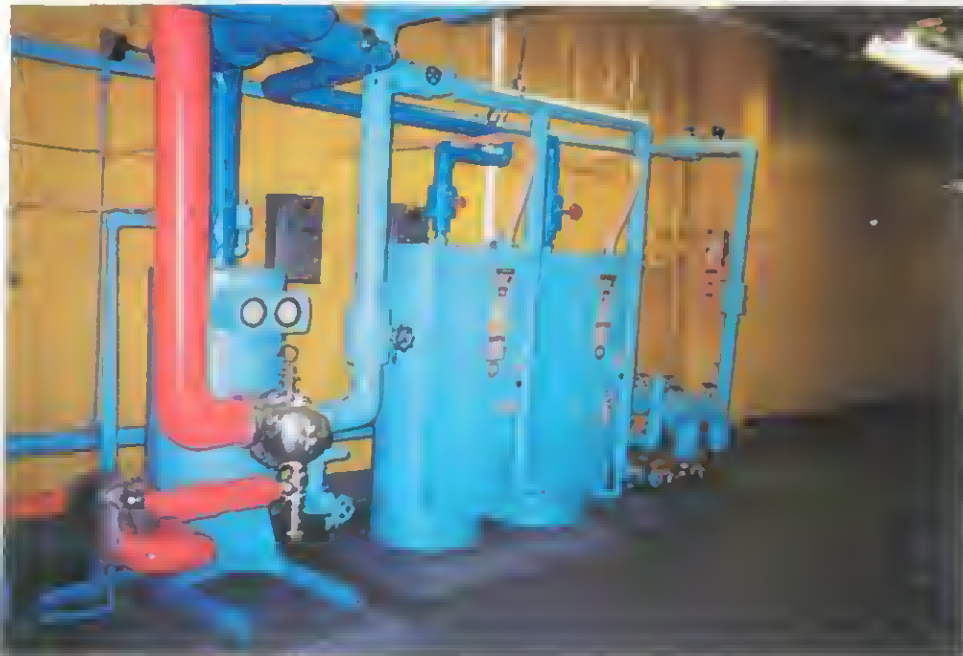
**Photograph M11**

Steam and  
electric domestic  
water heaters  
and circulating  
pumps

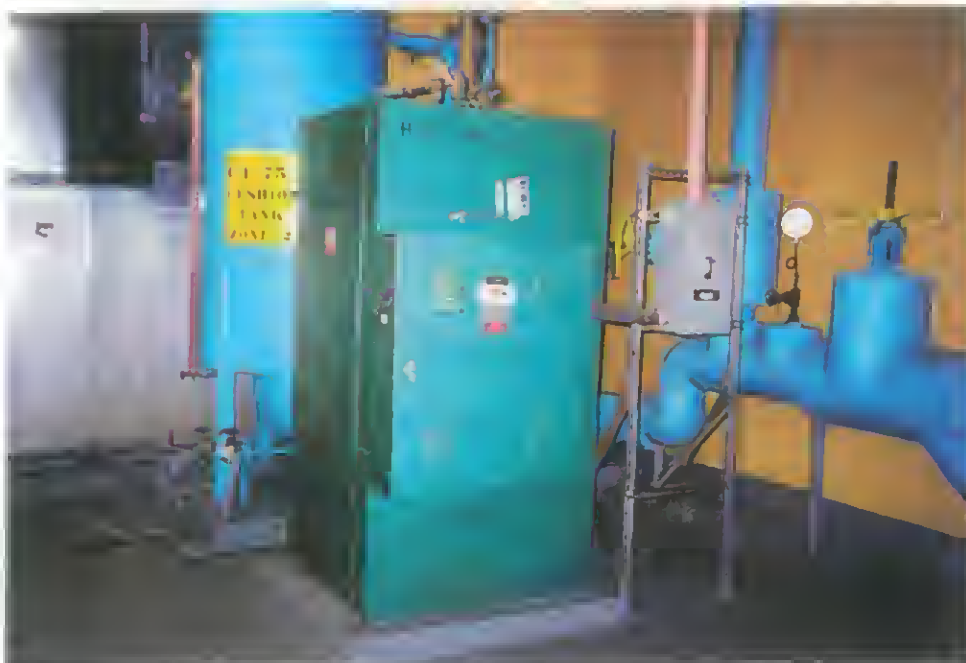
**Photograph 12**

Large electric  
water heater

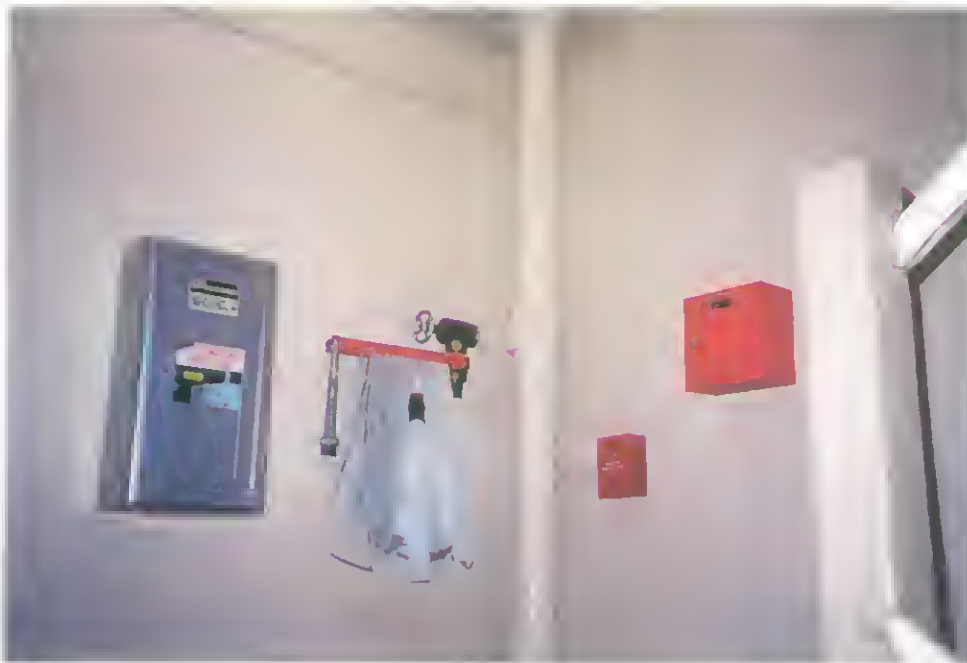
**Photograph M14**

**Standpipe riser with a fire hose rack and fire extinguisher cabinet located in the stairs**

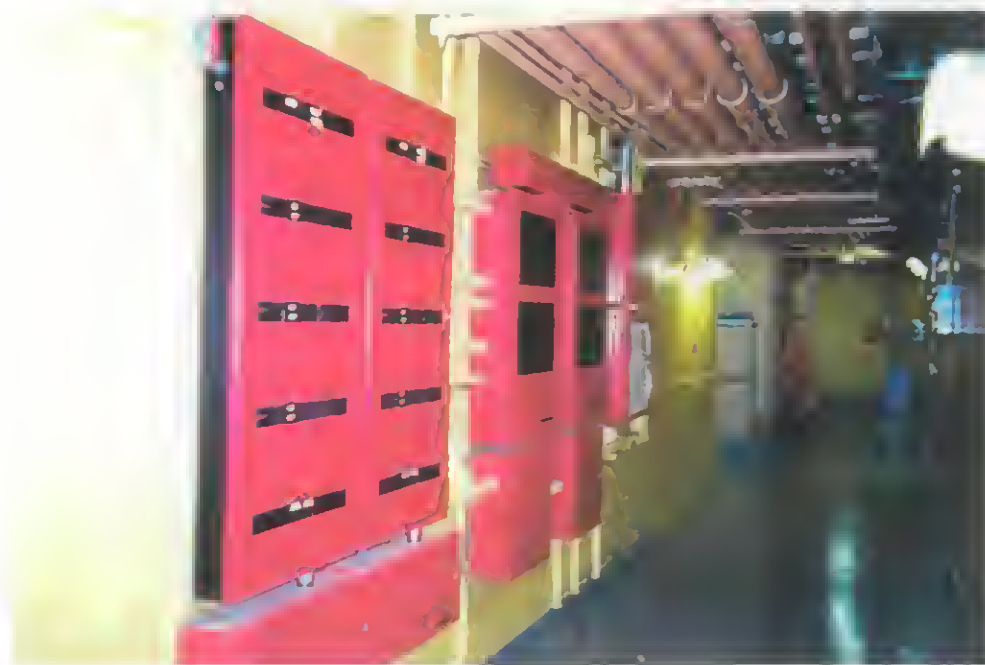
Photograph M15

Fire alarm  
panels for the  
new system being  
installed

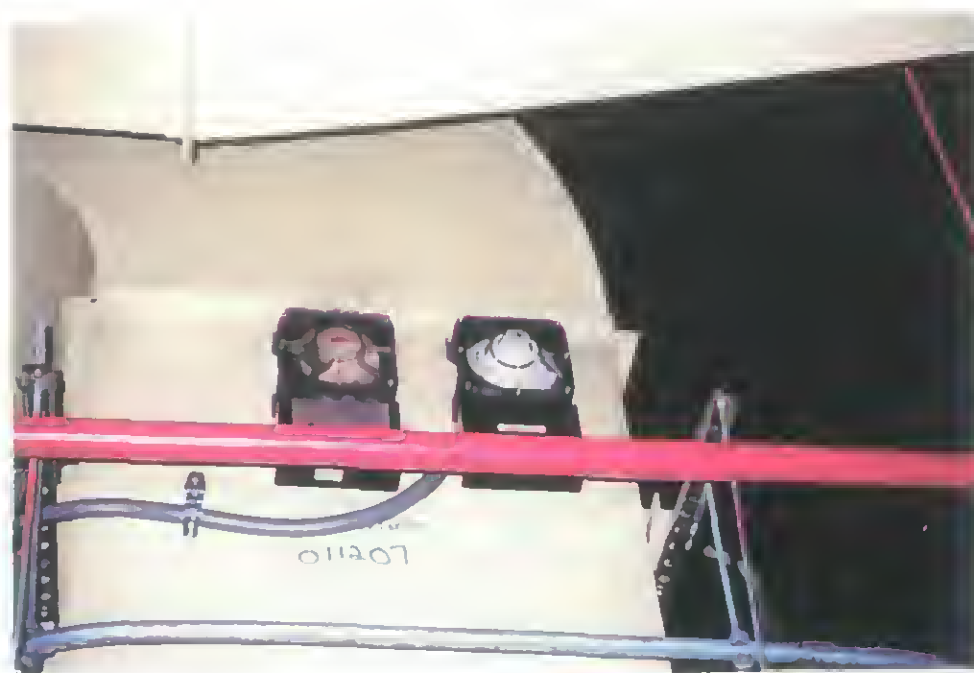
Photograph M16

Duct smoke  
detectors for a  
typical air  
handler

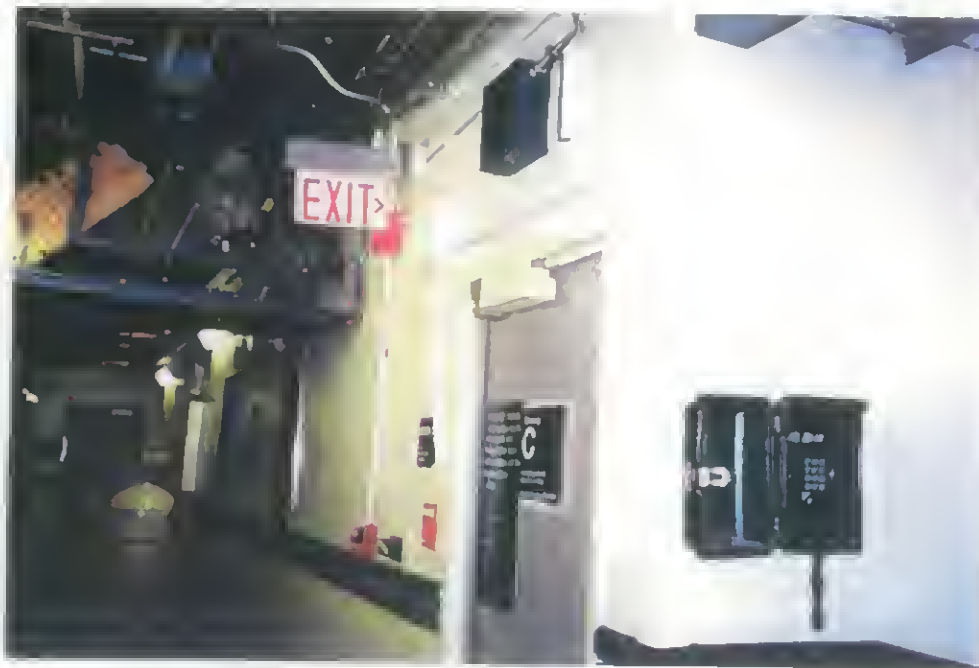
Photograph M17

Exit sign, manual  
pull station, and  
alarm

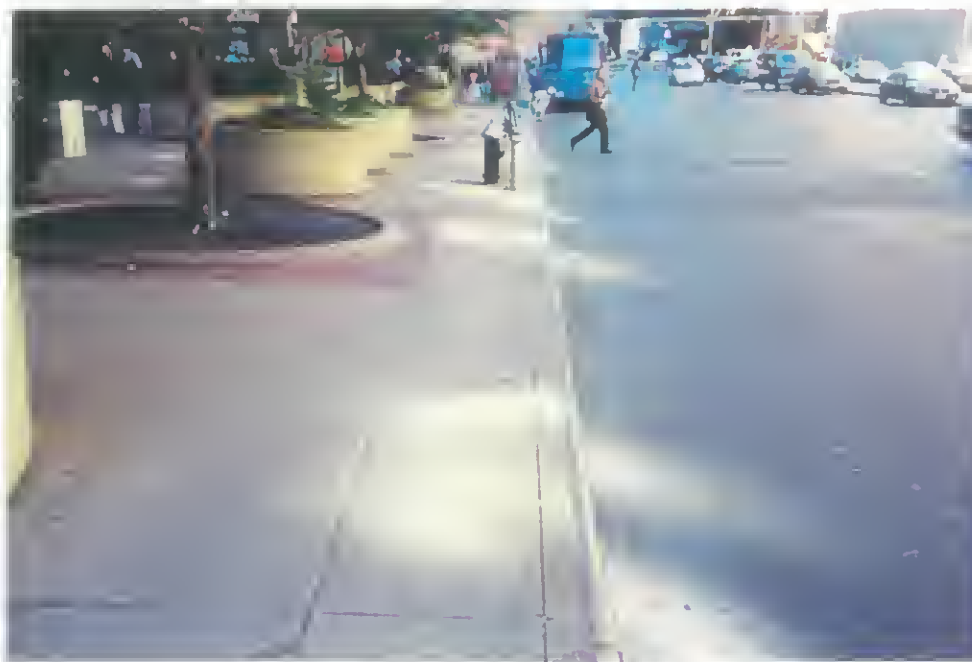
Photograph 2

Sidewalk, curb,  
and planter  
details on  
sidewalk looking  
west along Vesey  
Street

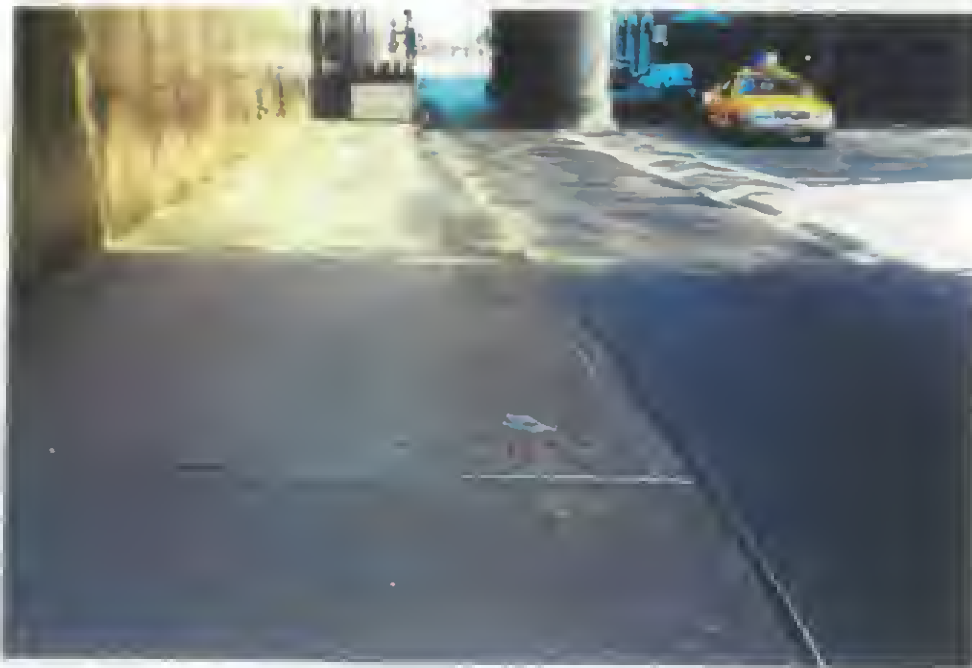
**Photograph 3**

**Sidewalk  
conditions along  
Vesey Street near  
West Broadway**

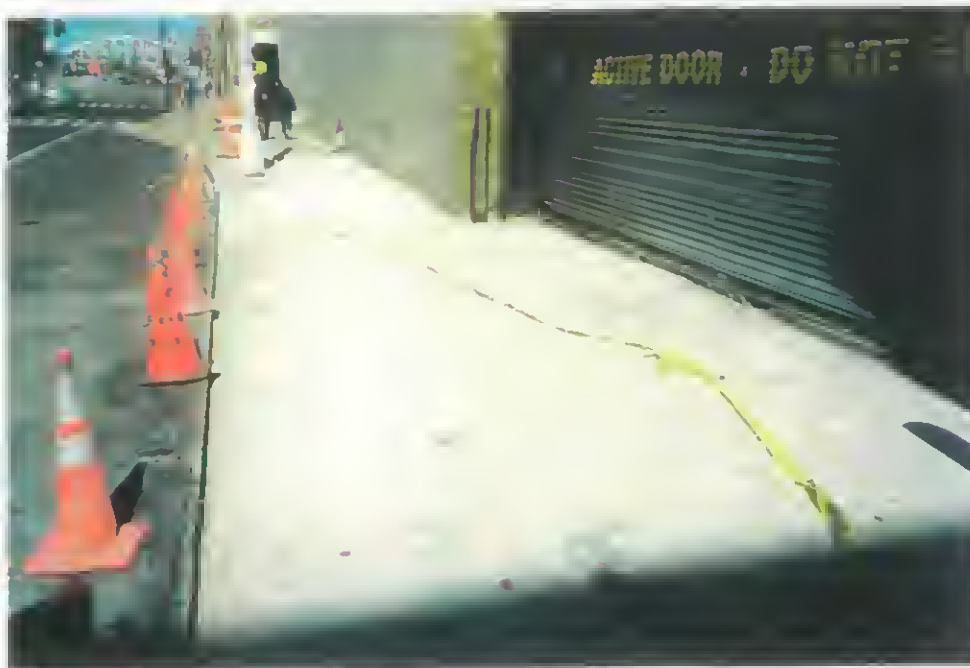
**Photograph 4**

**Sidewalk  
replacement in  
progress West  
Street near  
Customs House**

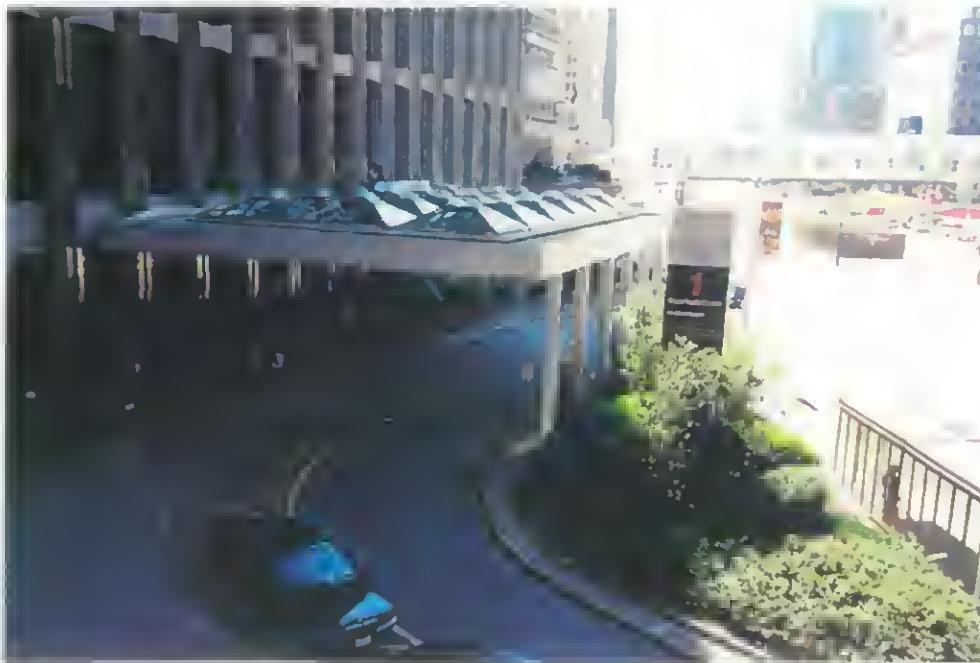
Photograph 5

Vehicular drop  
off at entrance to  
1 WTC on West  
Street

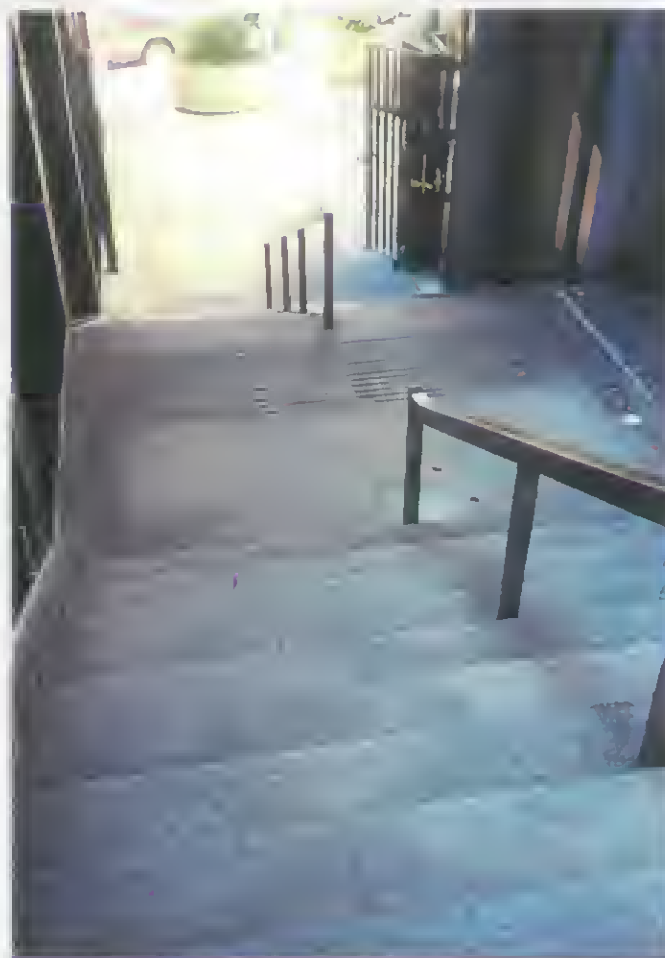
Photograph 6

Typical granite  
stairway from  
Plaza between  
WTC 1 and hotel

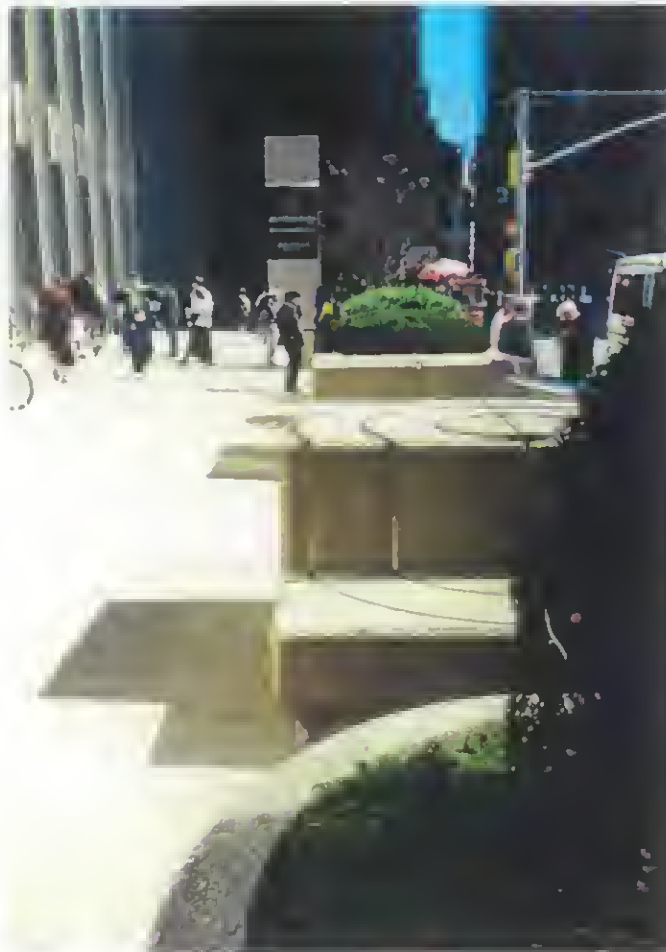
**Photograph 7**

Street furniture  
and pavement  
south of WTC 2  
along Liberty  
Street

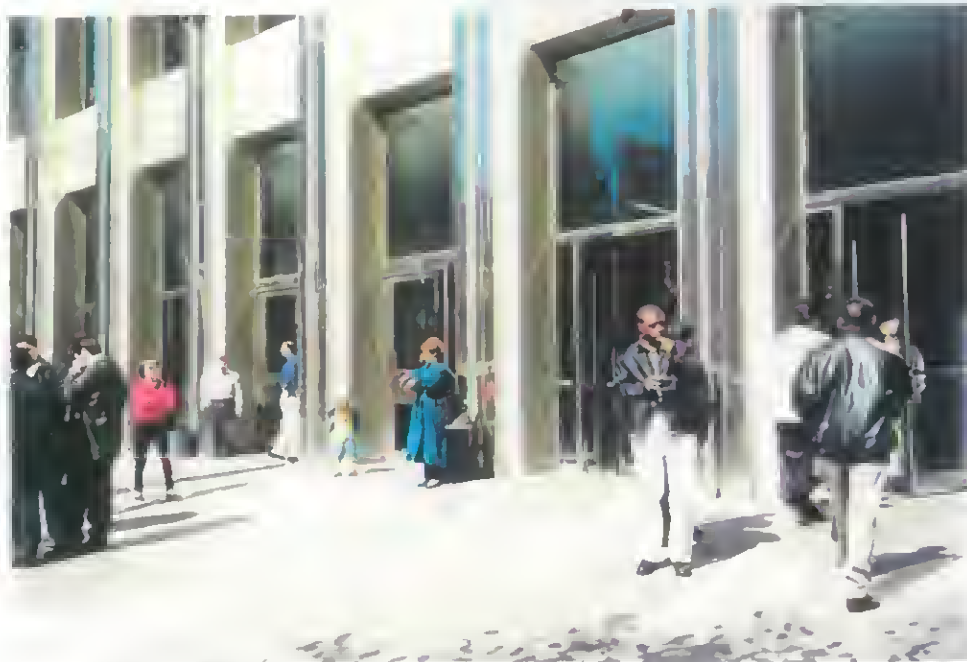
**Photograph 8**

New granite  
pavement south  
at 2 WTC  
entrance

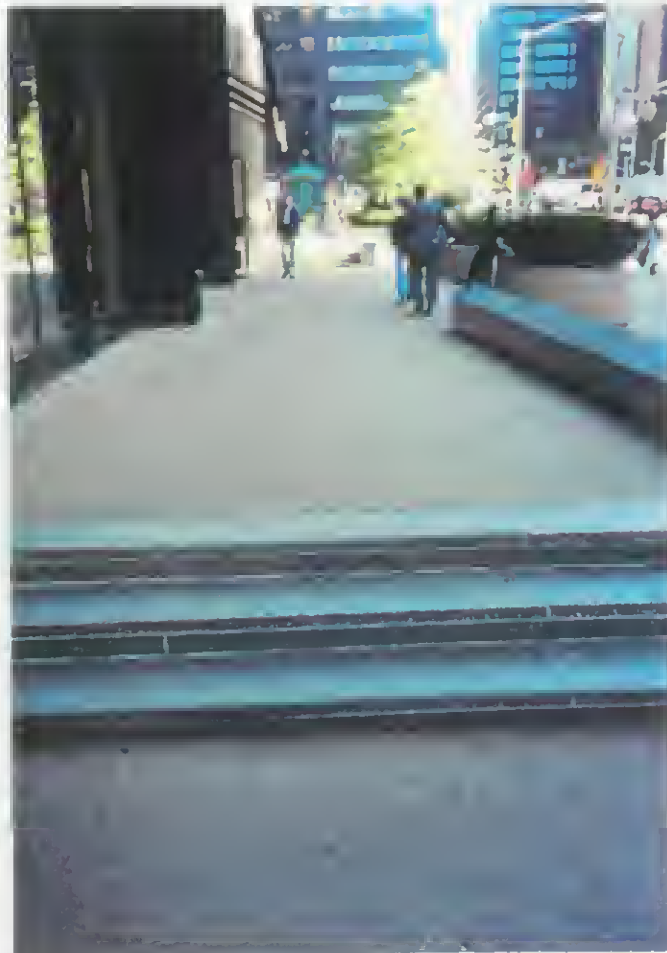
Photograph 9

Sidewalk and  
steps south of 4  
WTC at Liberty  
and Church  
Street

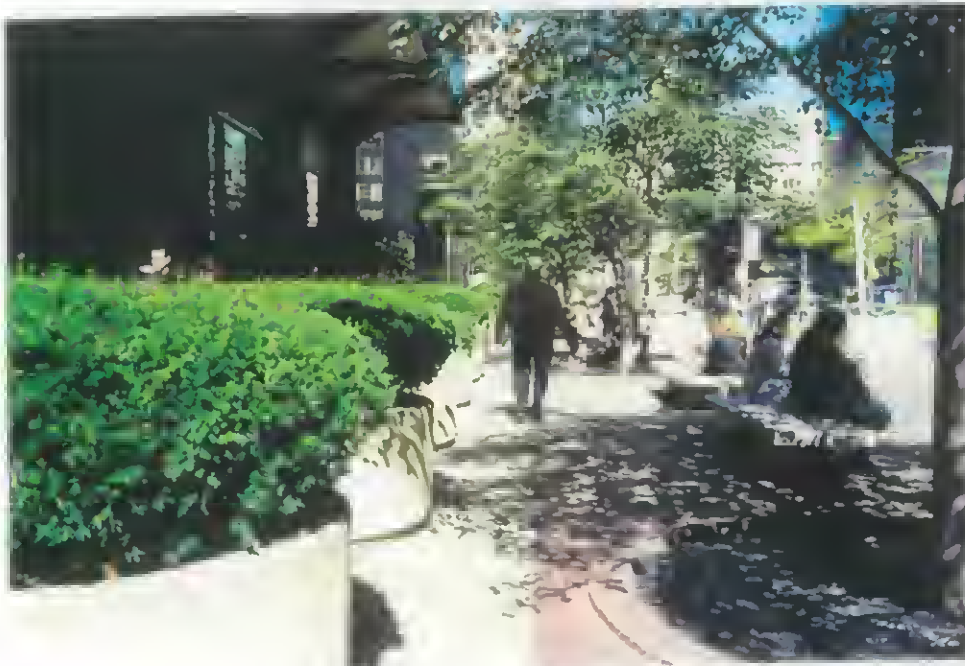
Photograph 10

Street furniture,  
planters, and  
tree wells along  
Church Street at  
4 WTC

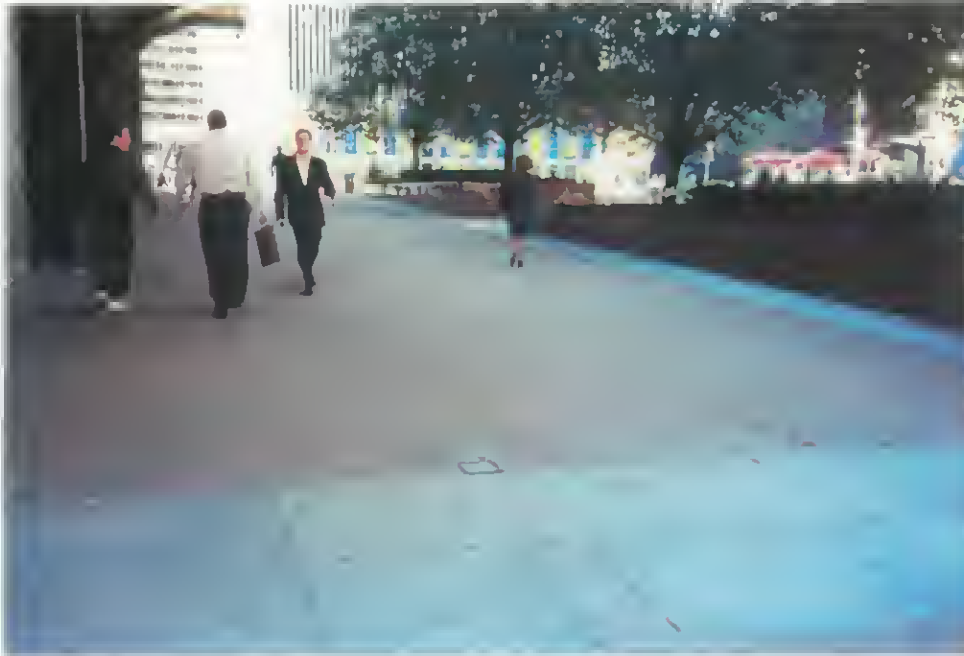
Photograph 11

Ramped  
entrance from  
Church Street  
looking west into  
Tobin Plaza

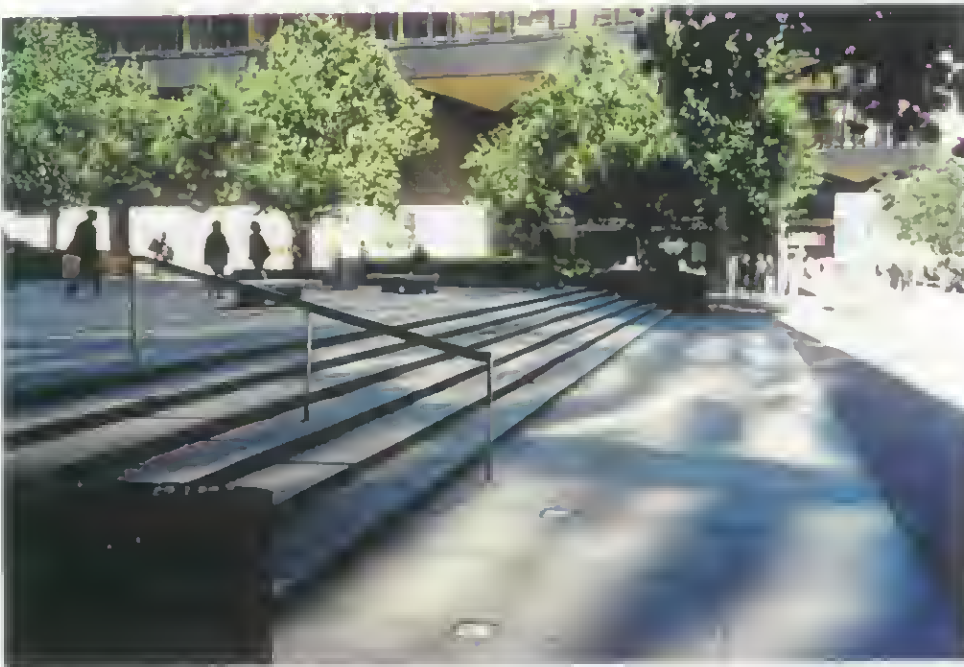
Photograph 12

Church Street  
steps entering  
Plaza

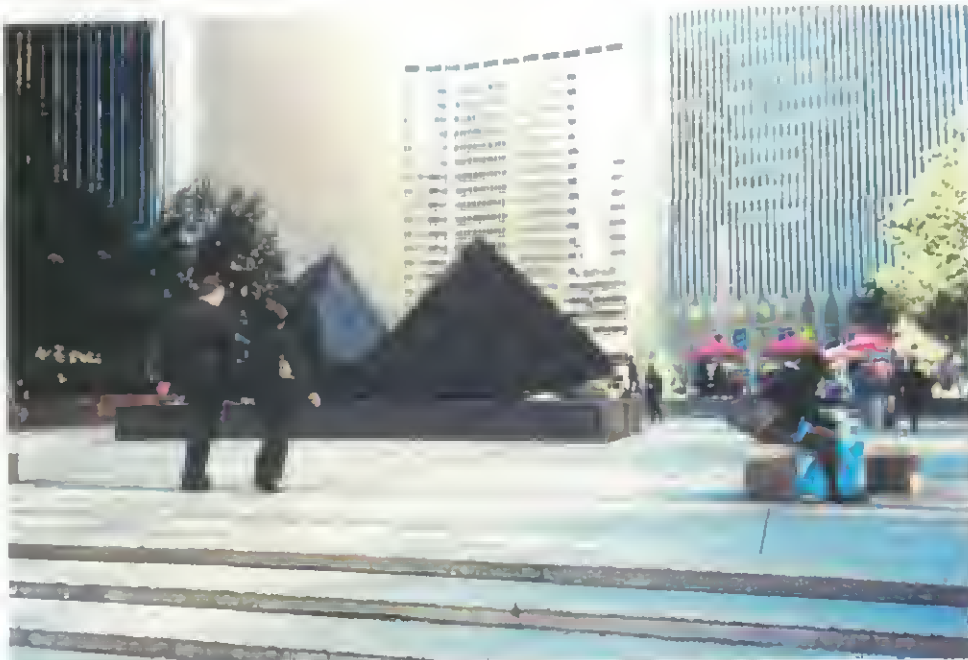
Photograph 13

Sculpture at  
entrance to Plaza  
on Church Street

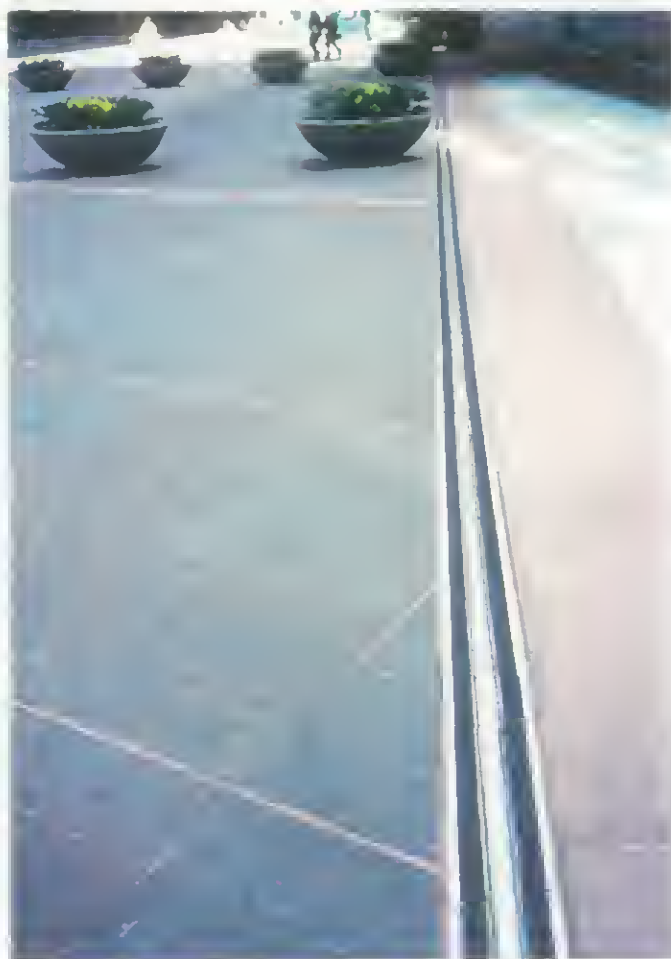
Photograph 17

Expansion joint  
in Plaza deck  
along east side  
near Church  
Street

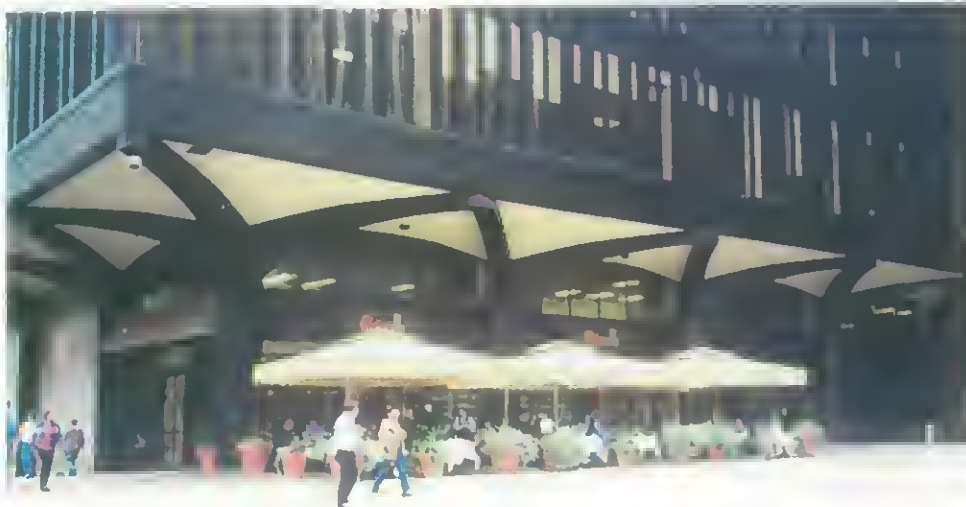
**Photograph 22**

Exterior finishes  
and space under  
overhang being  
used for  
restaurant  
seating

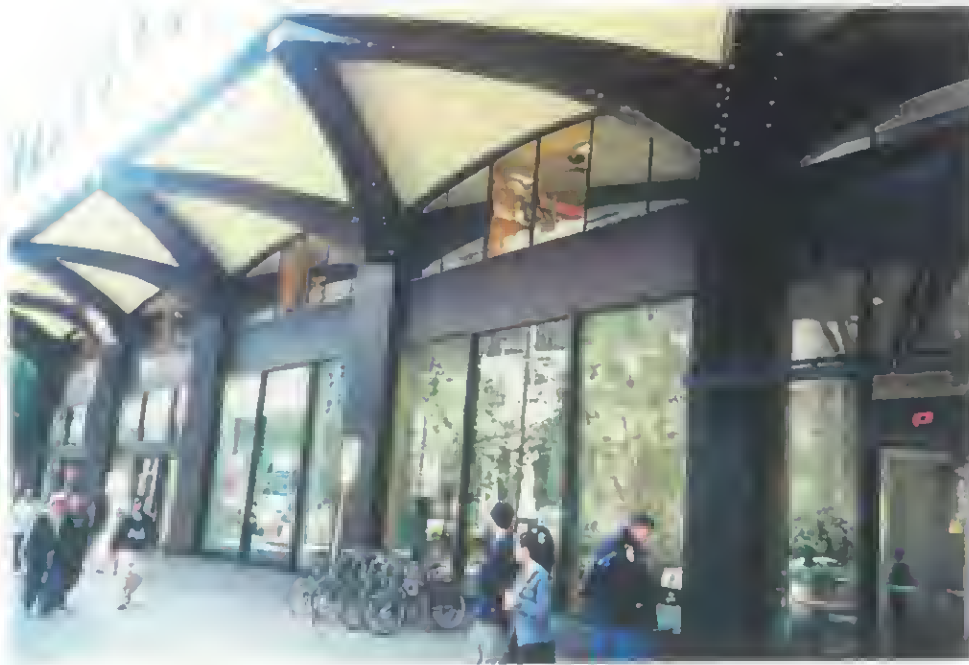
**Photograph 23**

Detail of exterior  
structure and  
finishes at 5  
WTC

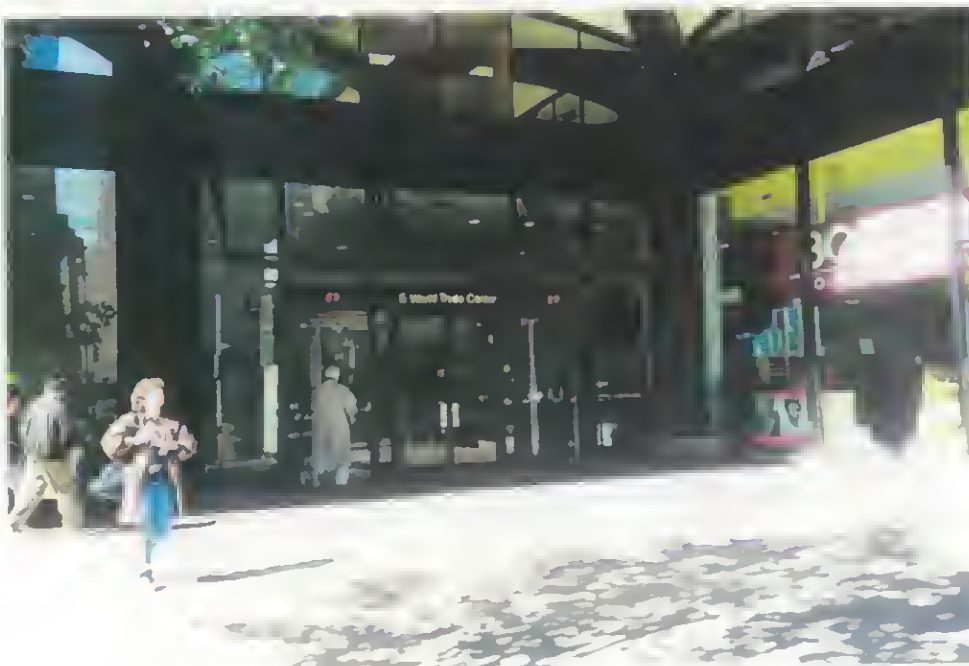
**Photograph 24**

Doors to  
northeast  
building  
entrance occur  
on a level  
between the  
Concourse and  
the Plaza

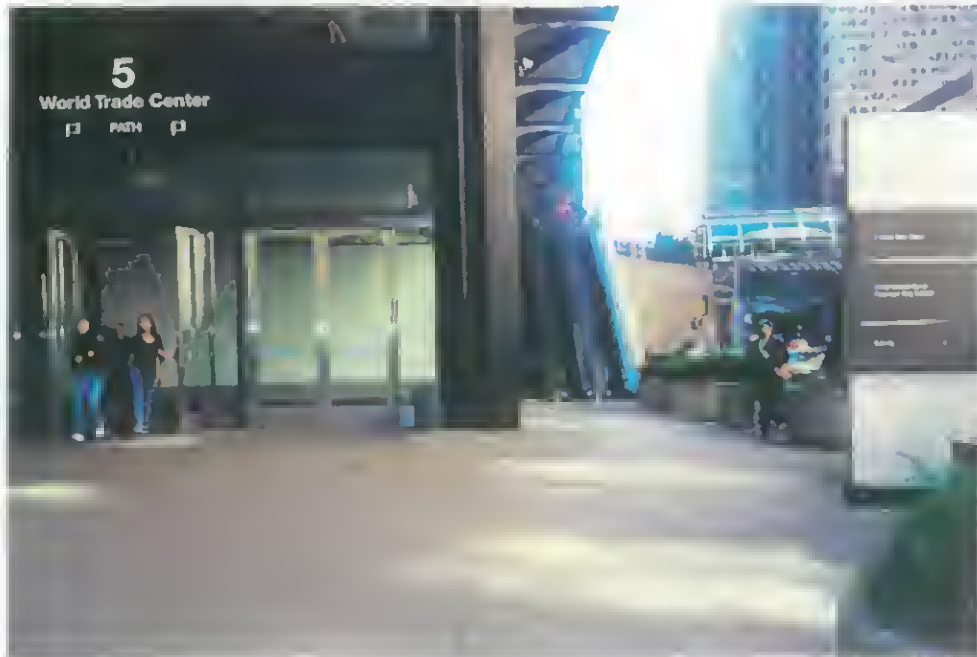
**Photograph 25**

Mall entrance  
detail along  
Vesey Street –  
Note exterior  
escalators to  
Plaza level on the  
right
